Case report

Open Access

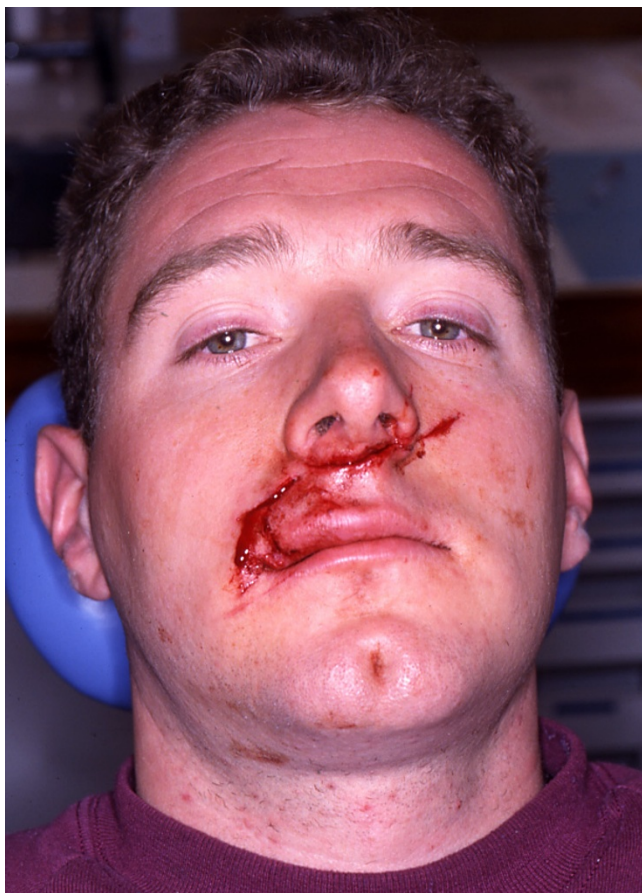
**Figure 1**  
Case 1 – pre-operative appearance.

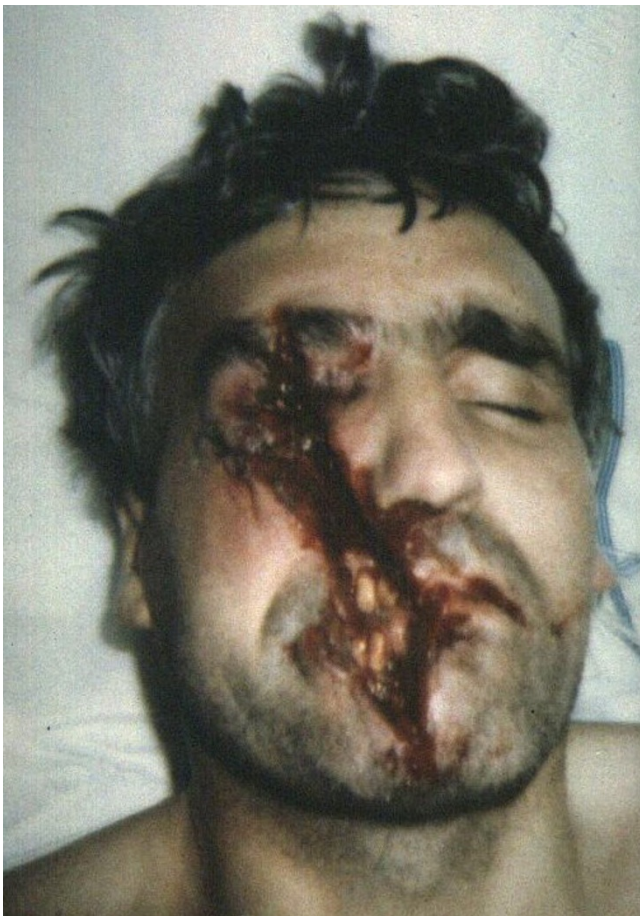
**Figure 5**  
Case 3 – pre-operative appearance.
